TAYLOR
CONDITION MONITORING

Thermal Imaging Survey Report

Sample Report

Report No. - Sample '12

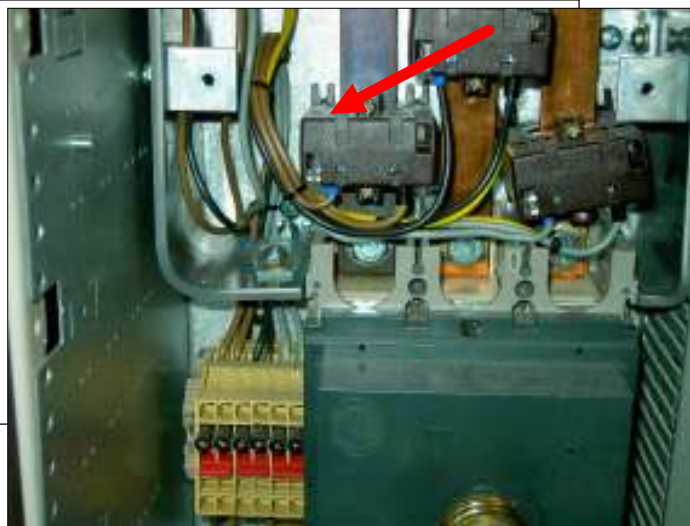
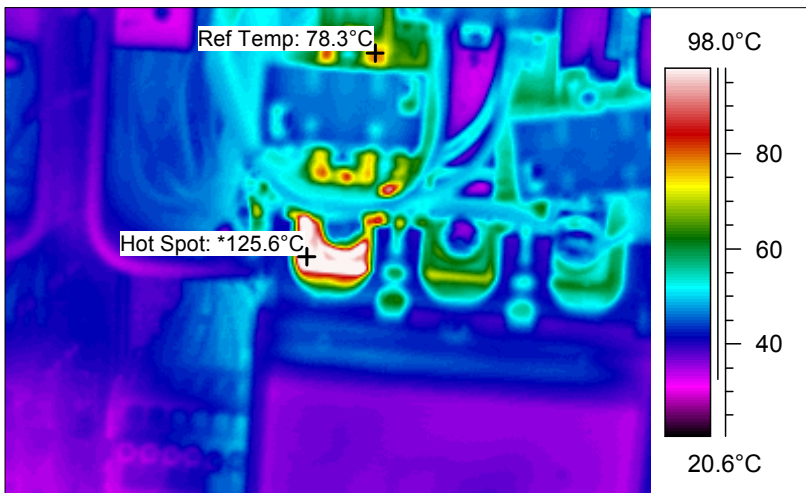
Persistence Pays Off
Plant reluctant to isolate for repairs.
Ref. next 2 pages for outcome.

Plant Room MCC 1-8. AHU 8 Section - Main Switch.
The switch's R phase spreader busbar is operating at 125.6°C.
Image captured June 18 approx. 1.00pm.
Serious fault - plant advised immediately.

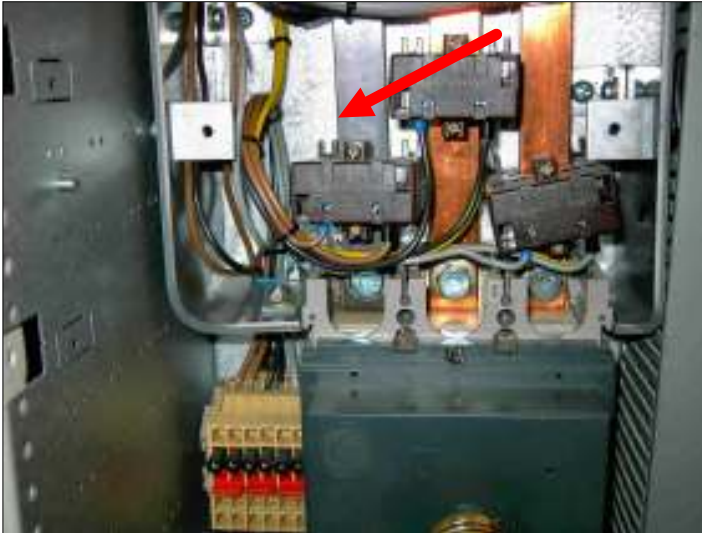
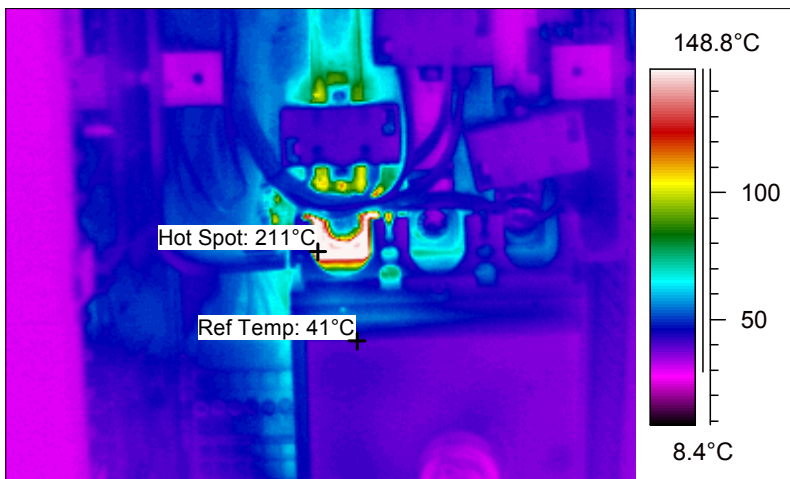
Fault from Previous page has escalated seriously in 24hrs.
Plant advised immediate action required to avert serious outage.

Plant Room MCC 1-8. AHU 8 Section - Main Switch.

The switch's R phase spreader busbar is operating at 211°C.

Image captured June 19 approx. 1.30pm.

Fault temp. has risen 85.4°C. in just over 24hrs.

Plant advised immediate action needed.

Switch immediately isolated and terminals tightened. R phase terminal was very loose. Switch re-energised.

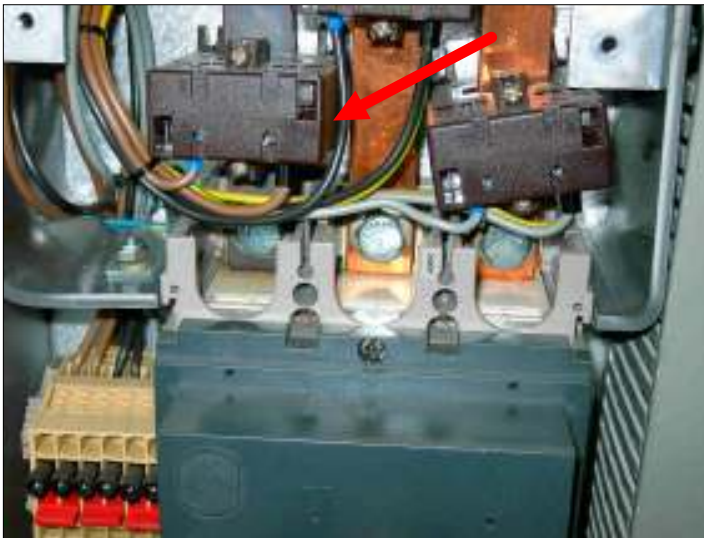
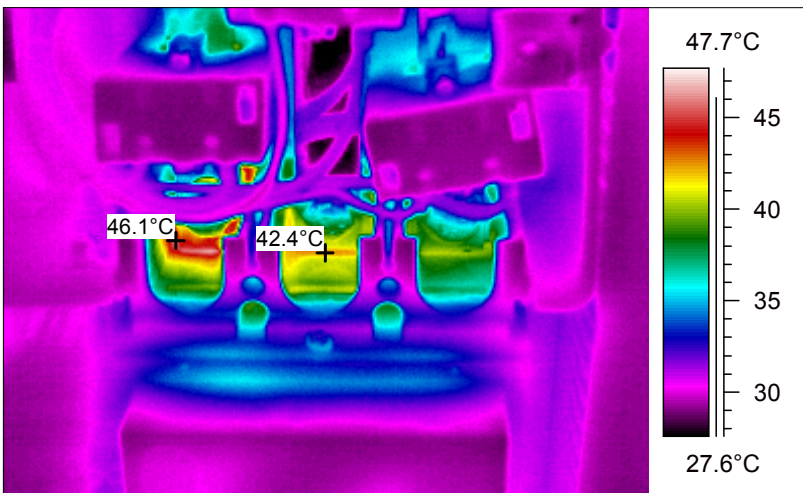
Fault Repaired.
Follow Up Action as advised very important.

Plant Room MCC 1-8. AHU 8 Section - Main Switch.
R Phase busbar at approx 3.00pm. June 19th.
Busbar is now operating at 46.1°C. and is normal.
A temporary fan was in use for 1hour to accelerate the switch cooling.
Switch and associated cabling should be scheduled for replacement as a priority. Monitor closely in intervening period.

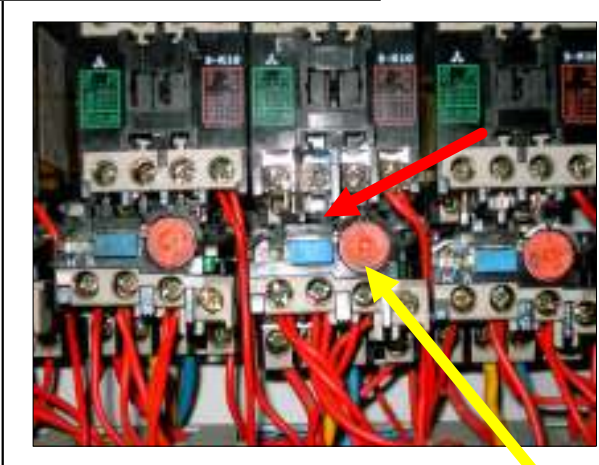
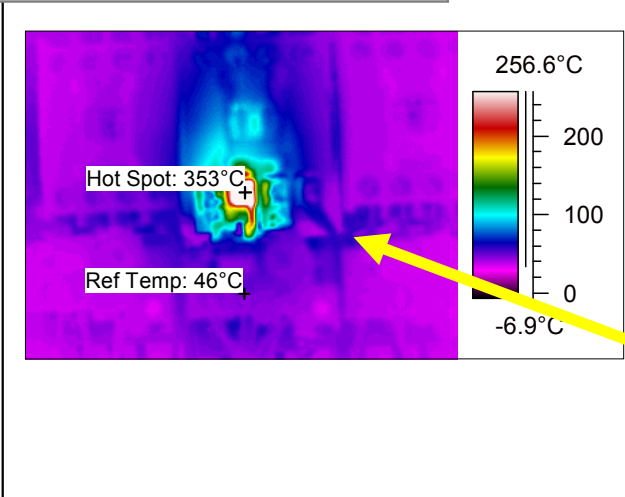
Company	Sample
Thermographer	Liam Taylor
Section	Refrigeration Plant Room
Equipment	APV Panel
Date	14/07/2009
File name	Ir_5367.jpg
Working conditions:

Description	Contactor Terminal Temp.
Label	Value
Hot Spot	353°C
Ref Temp	46°C
Temp Diff	306.8°C

Refrigeration Plant Room. APV Panel. Area 2 Contactor Enclosure. 2nd. Row. 3rd. Contactor from Left.
 The contactor's centre phase terminal is operating at 353°C.
 This is a serious fault and should be corrected as a matter of priority.
 Replace Contactor and overload unit.
 Inspect cables for heat damage and crop or replace as required.
 Plant advised of fault on day of survey.

Plant advised of Serious Faults immediately.

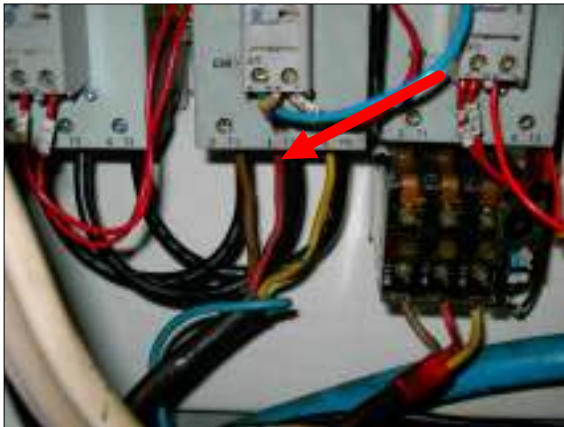
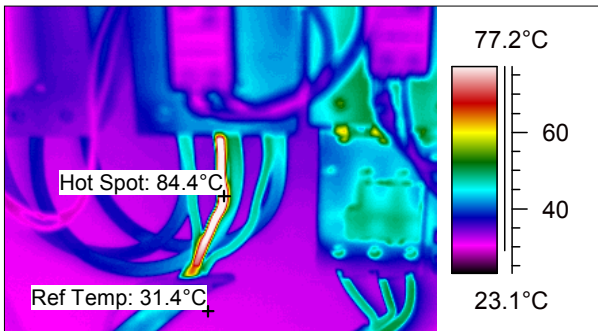
Company	Sample
Thermographer	Liam Taylor
Section	Refrigeration Plant Room
Equipment	Pak 3 Panel
Date	14/07/2009
File name	Ir_5368.jpg

Description	Cable Terminal Temp.
-------------	----------------------

Label	Value
Hot Spot	84.4°C
Ref Temp	31.4°C
Temp Diff	53.0°C

Refrigeration Plant Room. Set 3 Control Panel.
Cable A11 in Panel's Lower Left Corner.
 The cable's centre phase is operating at 84.4°C.
 Check the cables operating current loading.
 Ensure the cable is properly inserted into the contactor's terminal and fully secured.

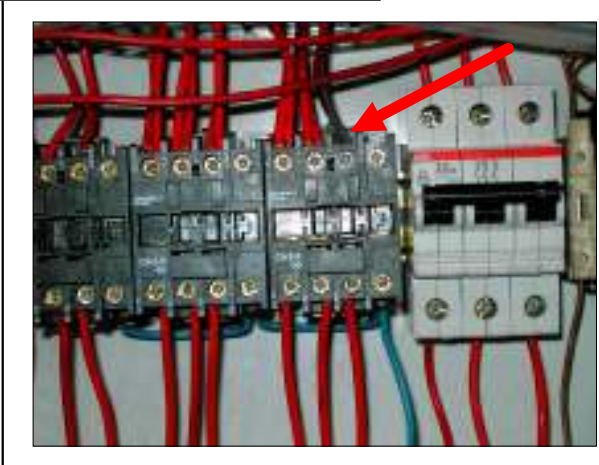
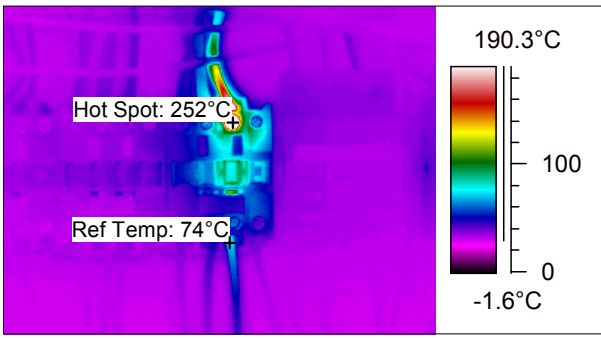
Company	Sample
Thermographer	Liam Taylor
Section	Building 2
Equipment	Chiller Panel
Date	14/07/2009
File name	Ir_5369.jpg

Description	Contactor Terminal Temp.
-------------	--------------------------

Label	Value
Hot Spot	252°C
Ref Temp	74°C
Temp Diff	178.3°C

Building 2. Chiller Panel. 3rd. Contactor from Left.
 The Contactor's top right phase terminal is operating at 252°C.
 Replace Contactor and crop or replace damaged cable sections.
 This is a serious fault and should be corrected as a matter of priority.
 Plant advised of fault on day of survey.

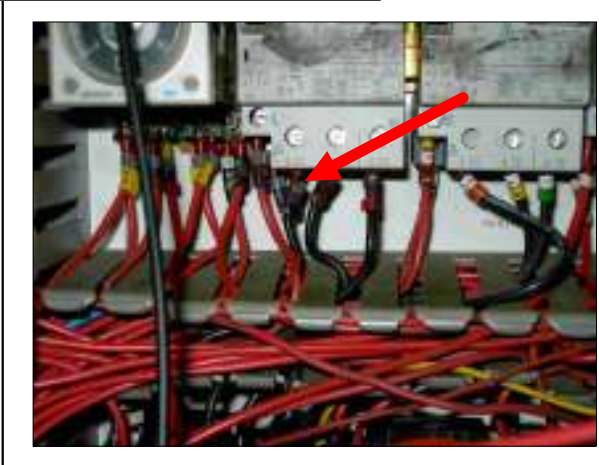
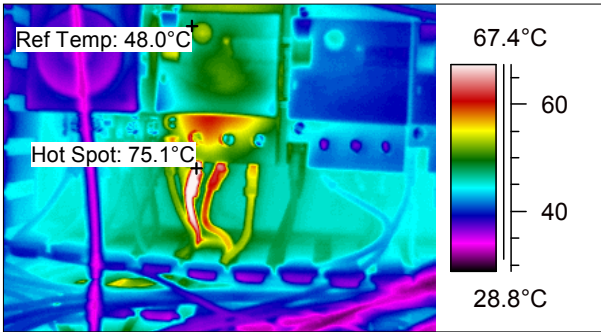
Company	Sample
Thermographer	Liam Taylor
Section	Building 2
Equipment	Final Unit Control Panel
Date	15/07/2009
File name	Ir_5370.jpg

Description	MCB 29 Terminal Temp.
-------------	-----------------------

Label	Value
Hot Spot	75.1°C
Ref Temp	48.0°C
Temp Diff	27.1°C

Room 2. Final Unit Control Panel. MCB 29.
 The MCB's lower left phase is operating at 75.1°C.
 Ensure MCB's terminal connections are fully secured.

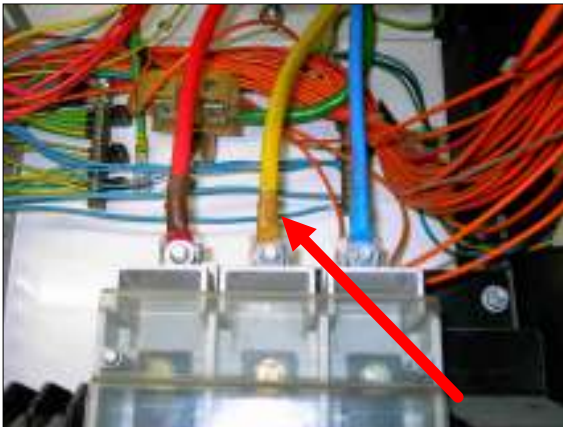
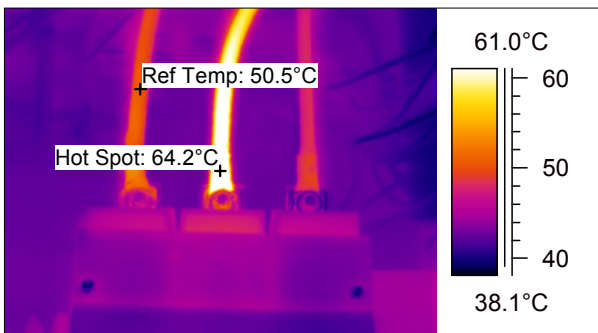
Company	Sample
Thermographer	Liam Taylor
Section	Conveyor Panel
Equipment	Section BK2-EP-45
Date	15/07/2009
File name	Ir_5371.jpg

Description	Panel Isolator Temp.
-------------	----------------------

Label	Value
Hot Spot	64.2°C
Ref Temp	50.5°C
Temp Diff	13.7°C

Conveyor Panel. Section BK2-EP-45. Panel Isolator.
 The Panel Isolator's top centre phase is operating at 64.2°C.
 Ensure the isolator's terminal connections are fully secured and that the cable's crimp connection is good.

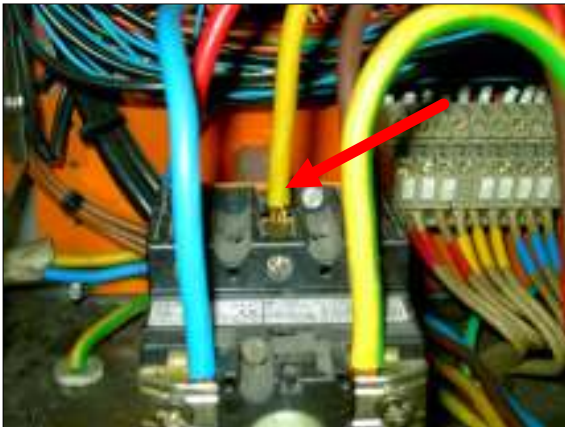
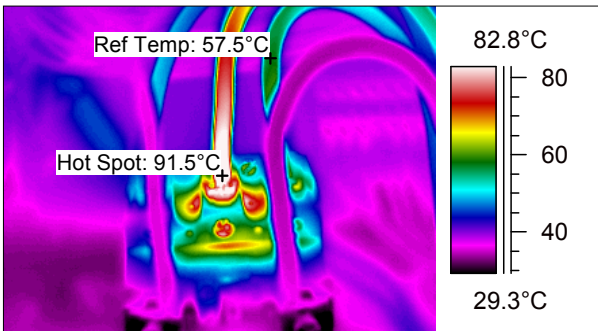
Company	Sample
Thermographer	Liam Taylor
Section	Packing
Equipment	Flow Wrap 6
Date	15/07/2009
File name	Ir_5374.jpg

Description	Panel Switch Temp.
-------------	--------------------

Label	Value
Hot Spot	91.5°C
Ref Temp	57.5°C
Temp Diff	33.9°C

Packing Flow Wrapper 6. Panel Switch.
 The Switch's top centre phase terminal is operating at 91.5°C.
 Ensure switch's terminal connections are fully secured.
