TAYLOR
CONDITION MONITORING

Vibration Analysis
Survey Report

Condition Based Maintenance Inspection
At
Company Name

Report No.: 001-01-12

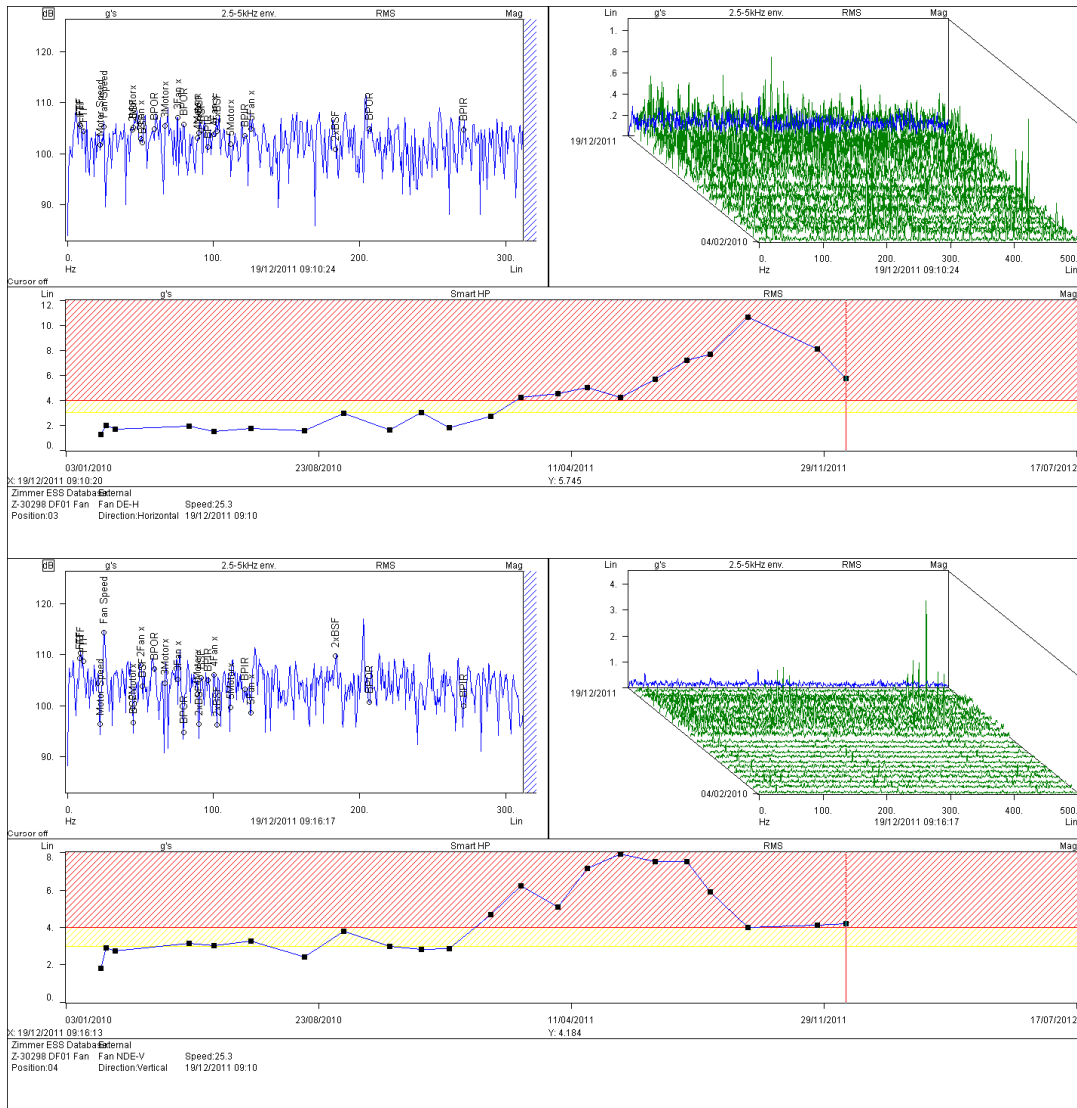
■ External – DF01 Extract Fan (Z-30298)

■ External – DF01 Extract Fan – Fan Support Bearings.

Monitor

General – Overall g's acceleration amplitudes measured from the fan shaft support bearings remain excessive although both bearings appear to be running at lower levels presently. Amplitudes remain 2 to 3 times higher than would be expected and are significantly higher than historical values. The overall levels remain a cause for concern and the Fan drive end bearing shows impact energy in the bearing envelope readings of 203Hz and harmonics, which is a match for the bearing outer race fault frequency.

It remains our recommendation to replace these bearings due to the excessive noise level and outer race impact energy.

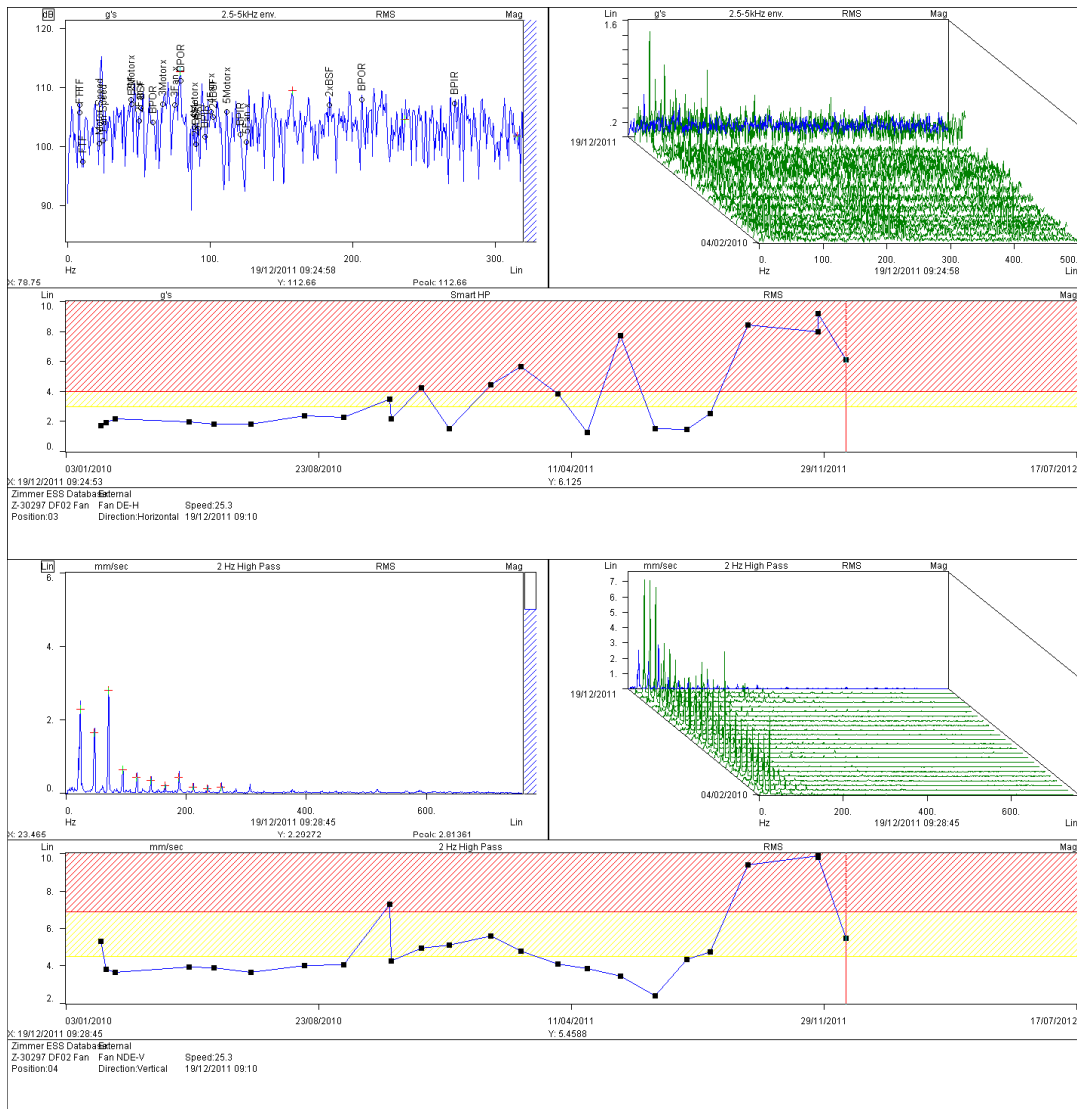
■ External – DF02 Extract Fan (Z-30297)

Imbalance remains evident, increase in bearing noise at Fan DE.

Imbalance – Readings obtained throughout the unit have shown a reduction of the mm/s velocity vibration at the fan shaft rotational frequency on this visit.

Fan DE – Readings from this bearing have shown a significant increase in overall g's acceleration noise levels. No bearing impact energy is evident within the enveloped data.

Please inform us of any corrective action taken. If no action has been taken previous recommendations apply. Maintain routine lubrication of the Fan DE bearing.

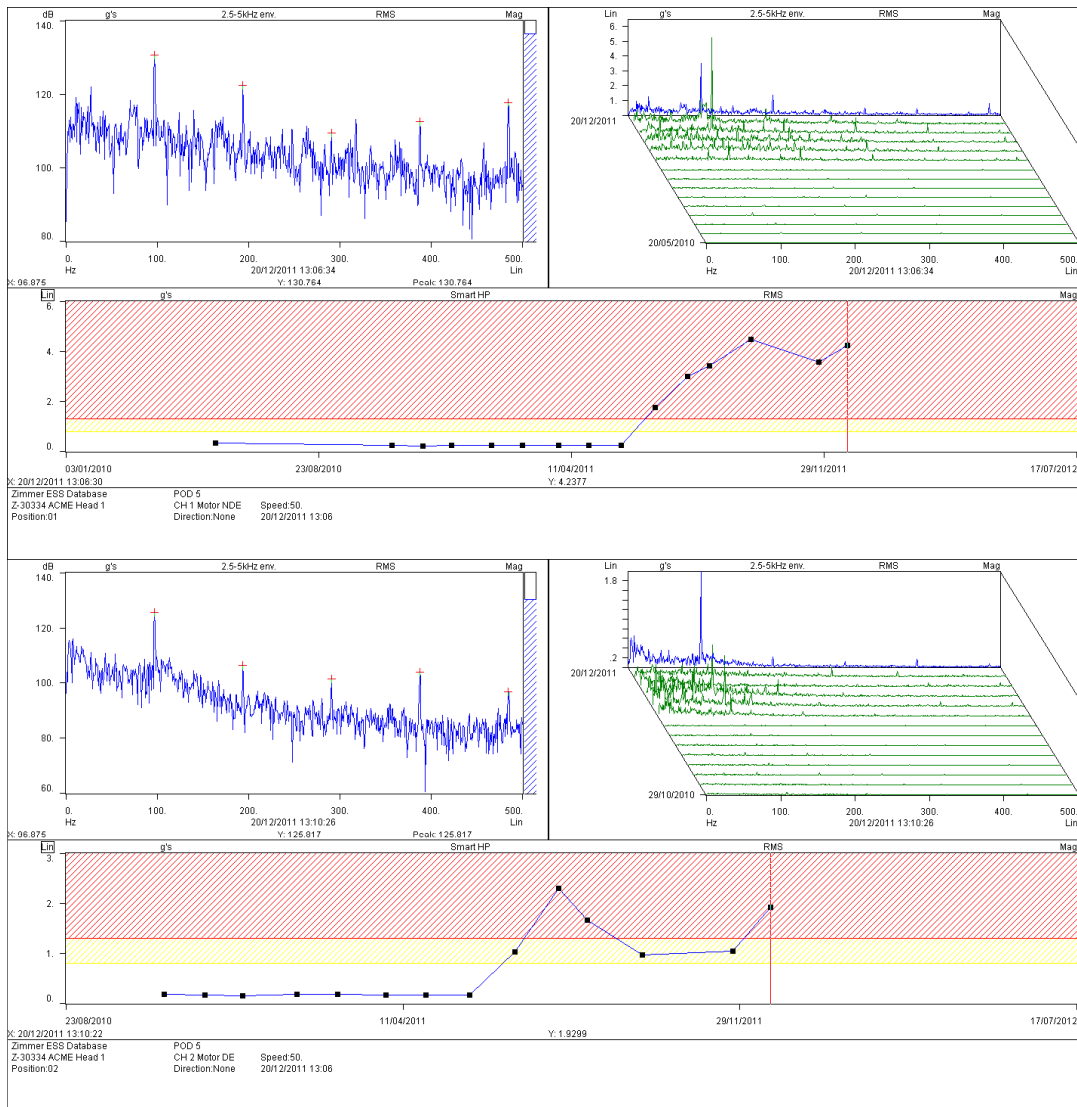
■ **POD 5 – Z30334 Head 1 – Motor**

Motor Bearings – Readings obtained from the motor bearings have shown a further increase in g's acceleration activity on this visit, both overall noise levels and impacting energy at frequencies possibly related to the bearings. Bearing numbers would be required to confirm this.

Motor bearing replacement suggested as soon as possible.

Replacement of the motor bearings is suggested as soon as possible.

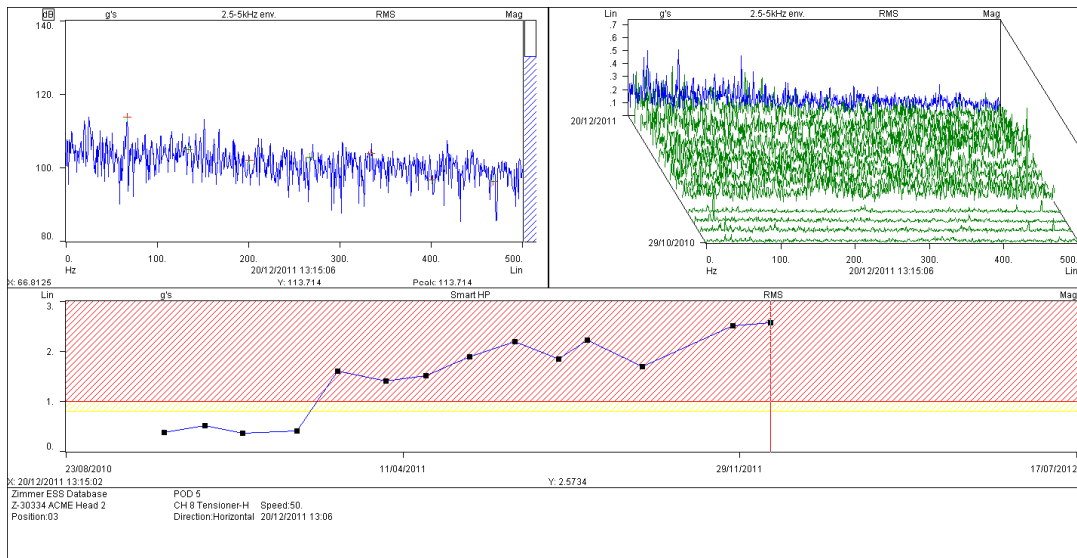
■ **POD 5 – Z30334 Head 2 – Tensioner Bearing**

Tensioner Bearing – Readings obtained from the tensioner bearings have shown a progressive increase in g's acceleration activity, overall noise levels are raising but no impact energy is evident at this time.

Tensioner bearing lubrication suggested.

The tensioner bearing should be replaced when possible.

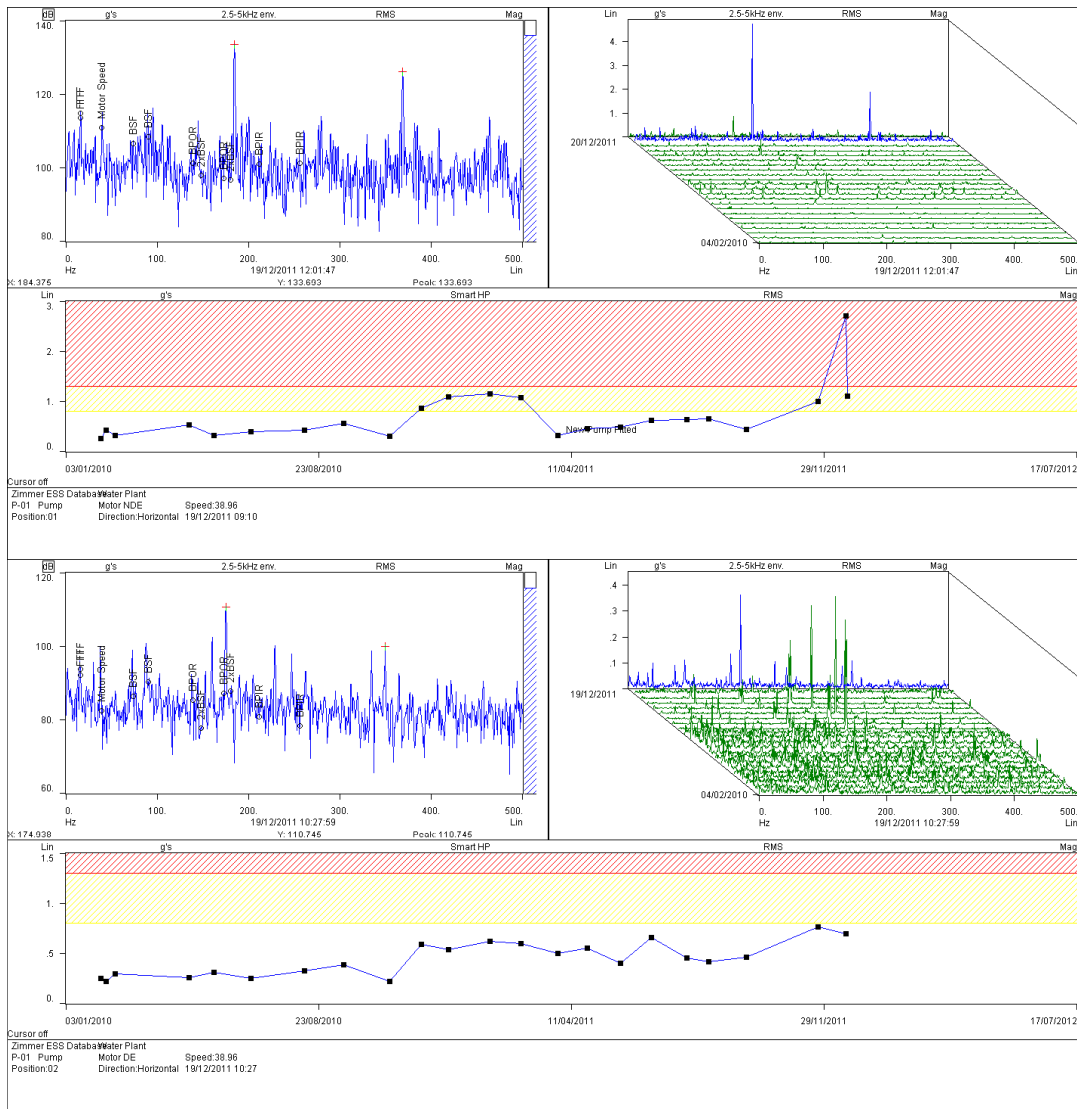
Water Plant – P-01 Pump – Motor Bearings

Motor Bearings – Readings obtained from the motor bearings have shown a significant increase in g’s acceleration activity on this visit. Evidence of increased overall noise levels is evident at two running speeds and the bearing data displays impact energy.

Bearing checks suggested.

Pump has been replaced and NDE bearing readings have dropped considerably but are still slightly high. Monitor during next survey.

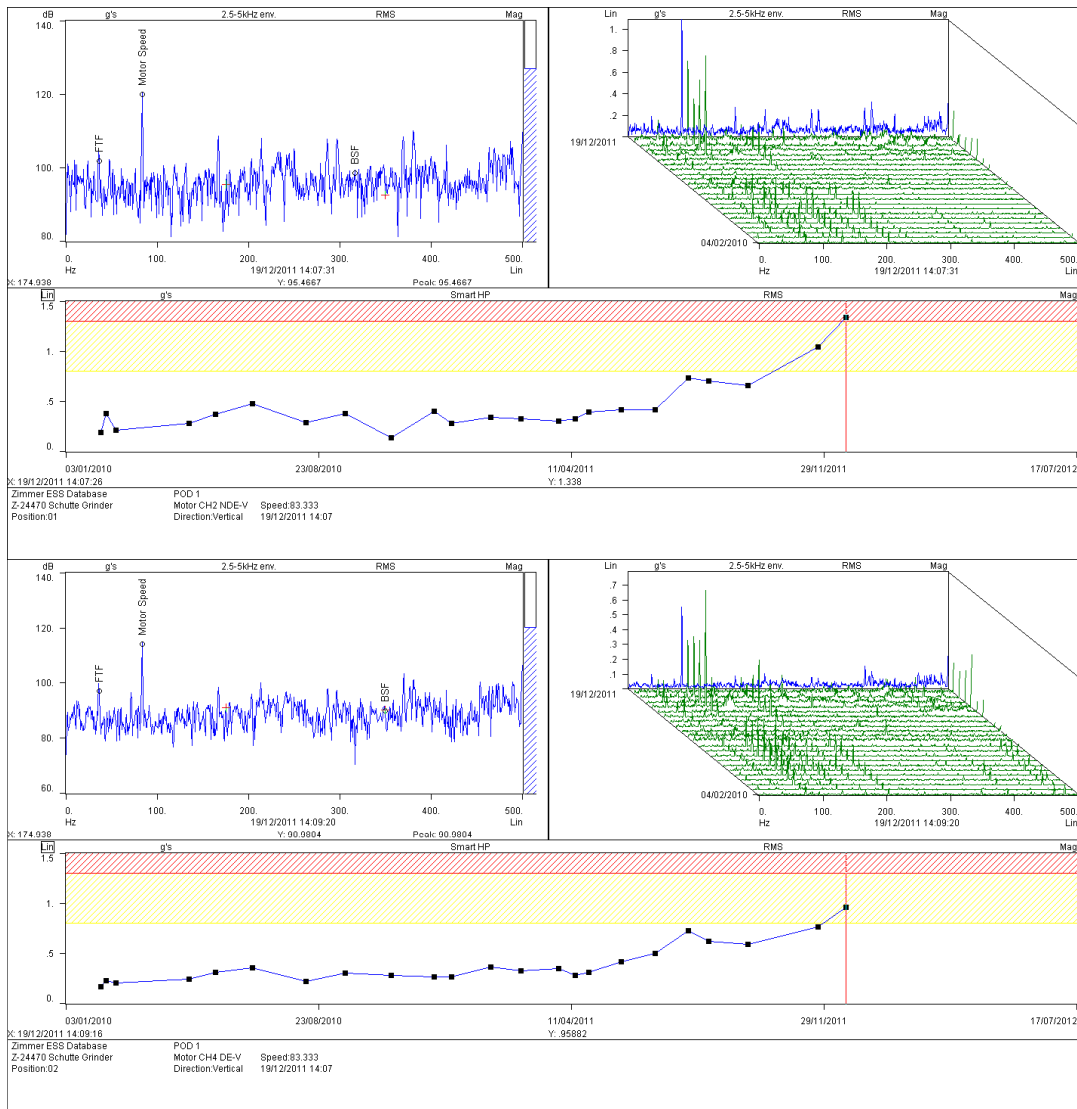
■ **POD 1 – Grinder Motor A (Z-24470) – Motor Bearings**

Increased bearing noise. Lubricate.

Motor Bearings – Readings obtained from the motor bearings have shown a progressive increase in g's acceleration activity on this visit. Evidence of increased overall noise levels is evident particularly at the motor NDE.

Monitor during the next survey and prepare to make a recommendation regarding replacement .

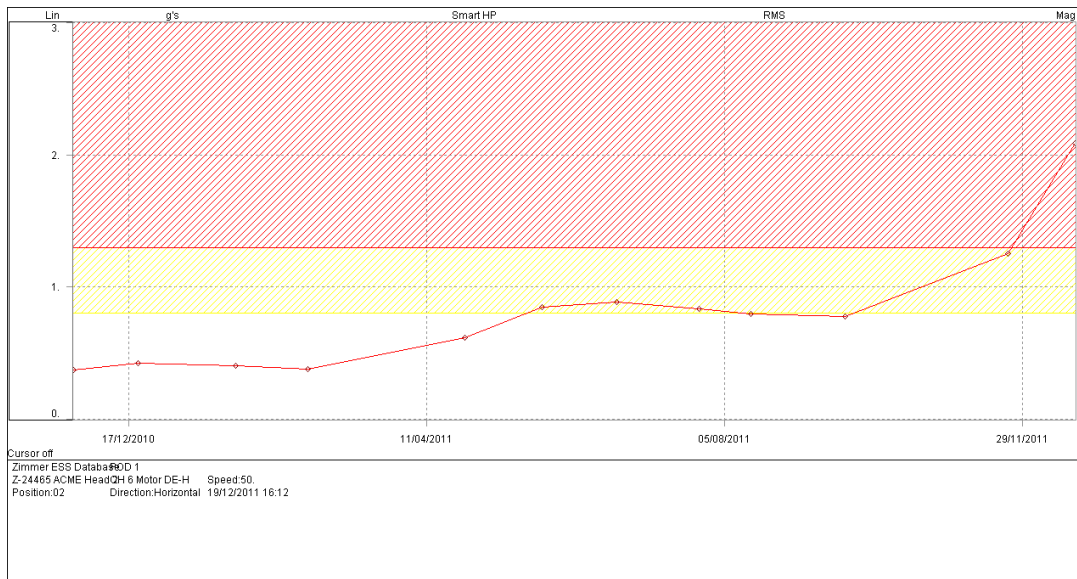
■ Pod 1 – Z24465 Head 2.

Increased noise level. Monitor during next survey and decide re. bearing replacement timing.

Motor DE Bearing – Readings obtained have increased considerably since Nov. reading.

Decide on bearing replacement timing after next reading.
